Severe Acetabular Defects: Image-Guided Reconstruction

Douglas Robertson NIH NIBIB 1 R21 EB003266-01

Workshop on Image-Guided Interventions

May 13 and 14, 2004

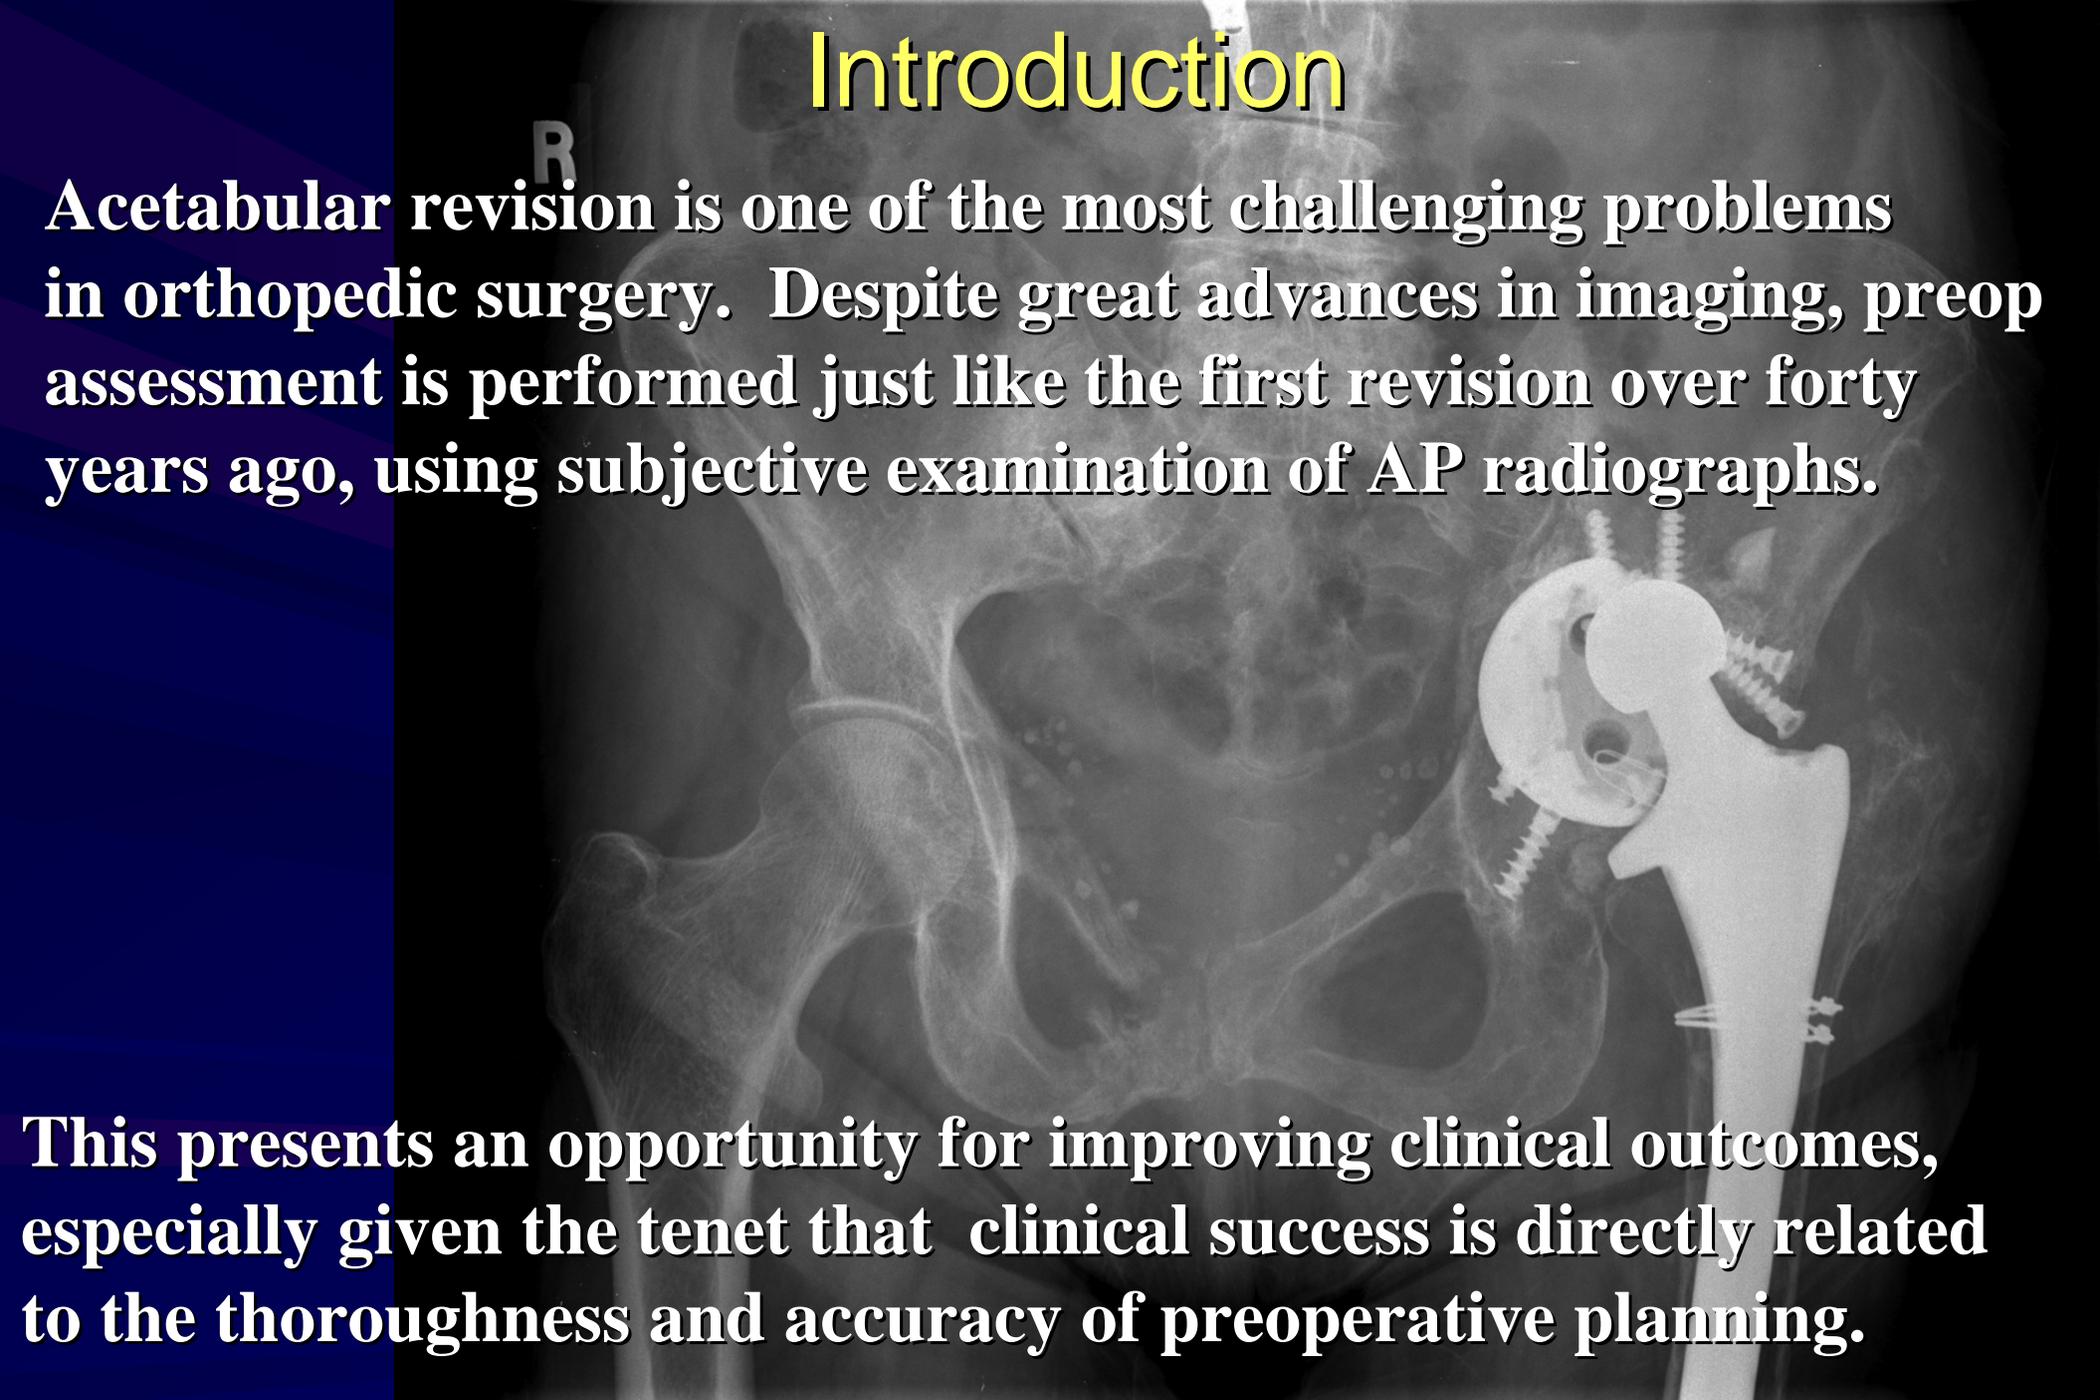
An anteroposterior (AP) radiograph of a human pelvis. The right hip (marked with an 'R') shows a revision acetabular component, which is a large, circular, metallic shell with multiple locking screws. A femoral stem is also visible, extending downwards from the hip joint. The background is a dark blue gradient.

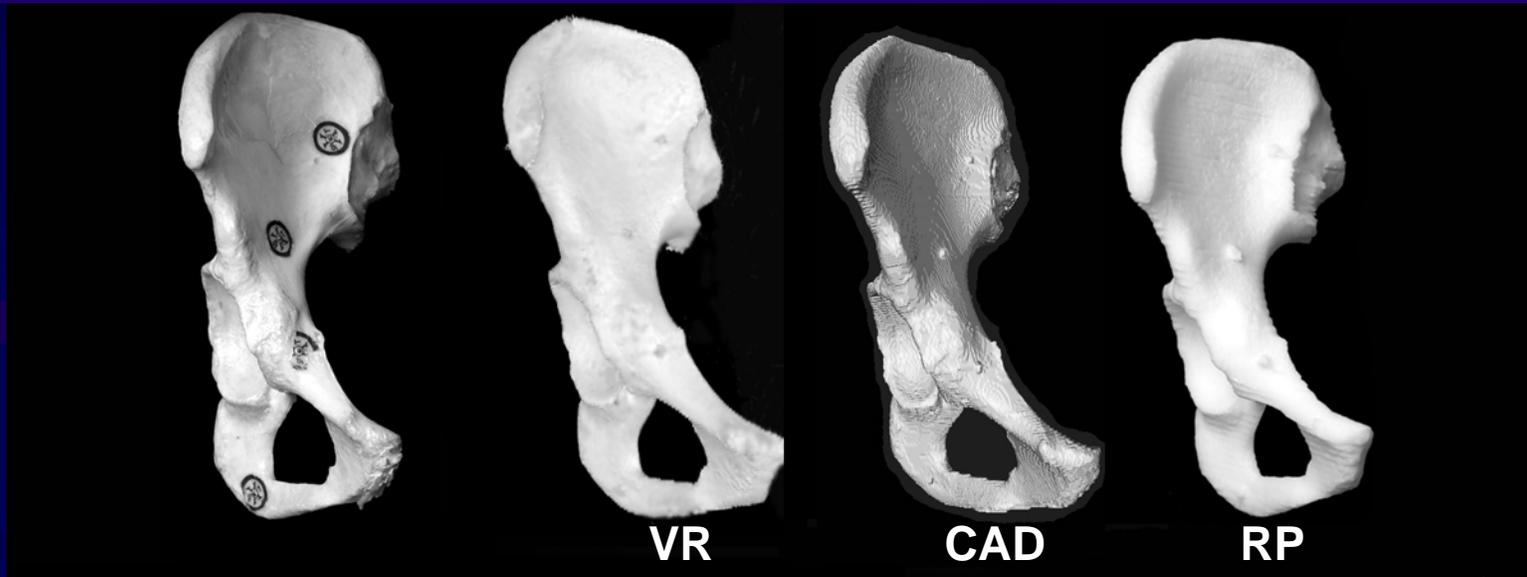
Preliminary Results- Aim 1 Linear Measurements

CT image sets overestimated caliper measurements, on average, by 0.3 ± 0.4 mm

3D models underestimated caliper measurements, on average, by 0.4 ± 0.9 mm .

Caliper, CT, and model measurements were highly **reliable**, with average repeat measurement differences of 0.1 mm.

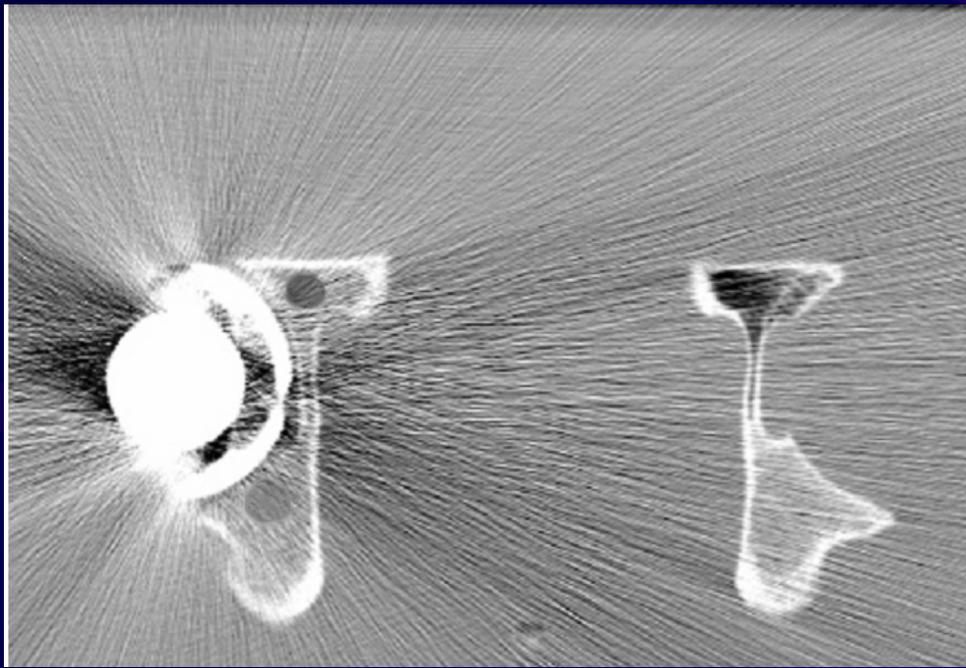
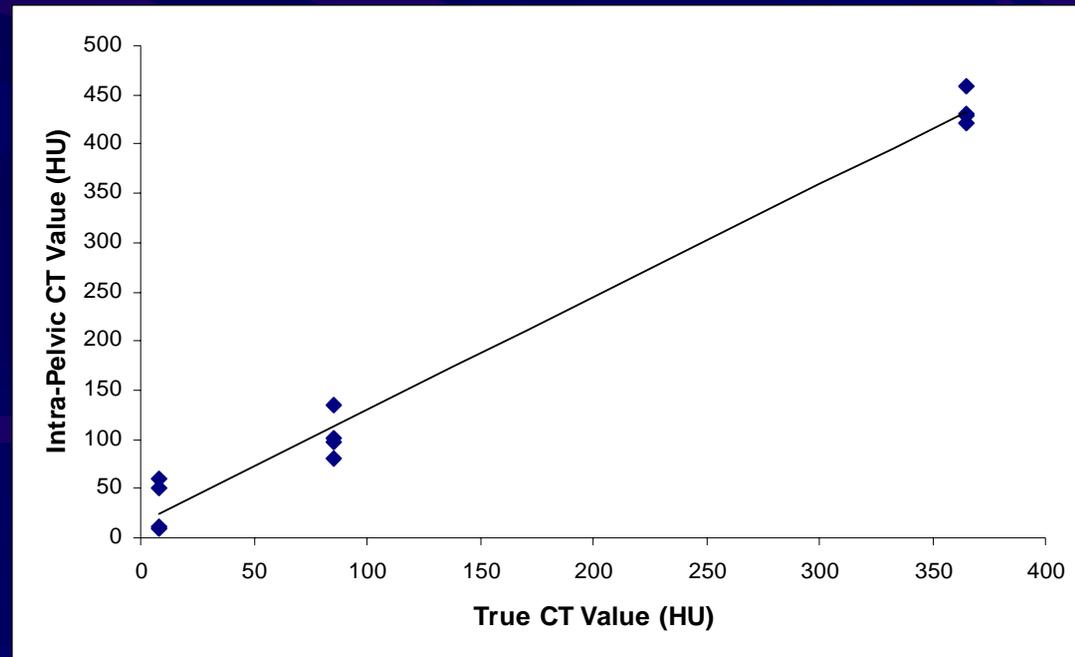
Preliminary Results- Aim 1 Density Measurements

Periprosthetic CT values within tissue equivalent cylinders can be corrected to their true values

$$CT_{\text{true}} = 0.91 CT_{\text{meas}} - 14.5$$
